THE USE OF GEOTEXTILE TUBES FOR EROSION CONTROL -

SELECTED CASE STUDIES

D. J. Trierweiler, P.E., Infrastructure Alternatives, Incorporated, Grand Rapids, MI, USA

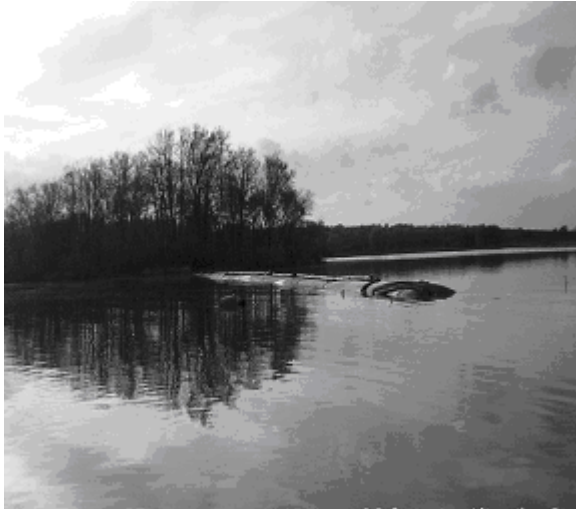
Figure 4 – Initial tube filling process

Horizontal alignment was established through the use of a transit as the proposed location of the geotextile tubes was laid out. After clearly delineating the work zone for local boaters, metal stakes were placed along the proposed tube line to identify the proposed lay out. The first of two 390' tubes was deployed by suspending the rolled up tube above the ground with an all-terrain fork lift, then pulling the end and unrolling it in the water. In its empty state, the geotextile tube floated on the water, thereby allowing easy positioning and adjustment. Stakes were used to tie the tube off in the proposed position. The 8" polyethylene and flexible hosing transfer piping system was connected from the 8" auger head dredge to the geotextile tube fill ports, and the filling process commenced. As the tube received the sand/gravel/sediment slurry, it naturally began to sink towards the lake bottom.

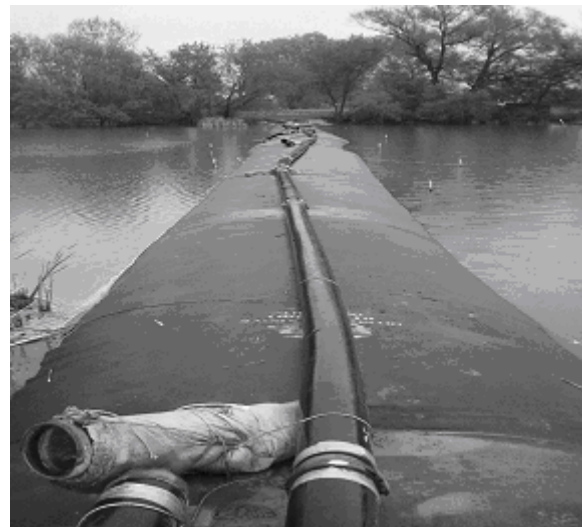
Figure 5 – Final tube fill height

The filling process continued until the contents of the geotextile tube were solid, and the top of the tube protruded above the water line. A screened passage was constructed from the end of the tubes to the shoreline at the eastern end to allow water flow and to prevent fish passage. Additional slurry was pumped from the lake bottom to the back side of the geotextile tubes to stabilize the tubes and to promote aquatic plant growth.

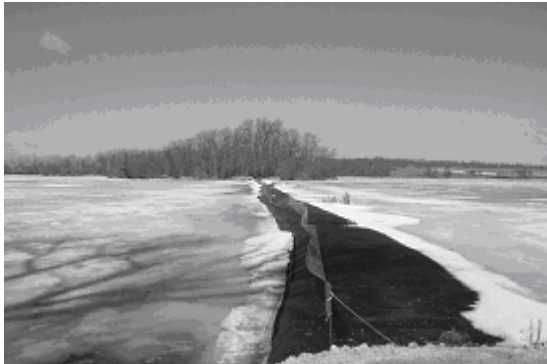
Figure 6 – Tube surrounded by ice

consideration. Furthermore, the tubes need to be clearly identified for winter sports enthusiasts. At Lake Sinissippi, the impact of the sheets of ice after the first winter was negligible or non-existent. The tubes were well marked by the lake association.

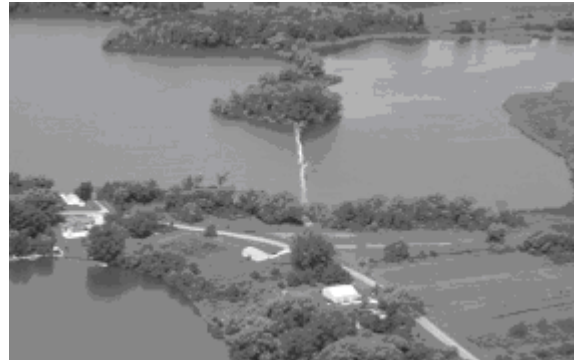
Figure 7 – Aerial view of geotextile tube breakwater

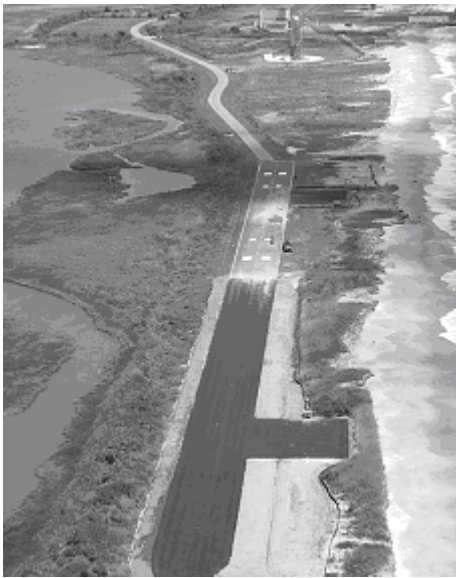
Figure 10 – Aerial view of project site

Two slurry pits, where off-site sand was mixed with water pumped from the ocean and/or estuary, were established. The first one, towards the north end of the project site, was adjacent to about 5,000 cubic yards of sand that had been hauled in from off-site and stockpiled. It was positioned such that it allowed a pumping distance of about 300' to the north, and about 1,300' to the south. The second slurry pit, located near the halfway point of the project, allowed pumping to the north for about 800', which met the limits of the southerly pumping from the north slurry pit, and pumping to the south of about 2,300' to the southern end of the project. Nearly 9,500 cubic yards of sand had been stockpiled adjacent to this slurry pit, thereby requiring the majority of the pumping from this pit.

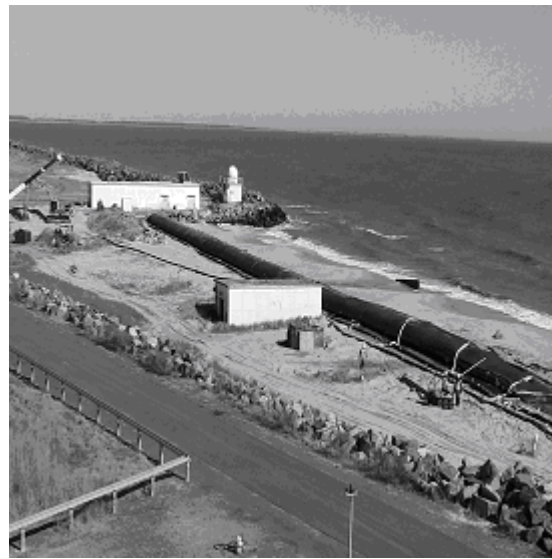
Figure 11- Initial filling at northern end of project site

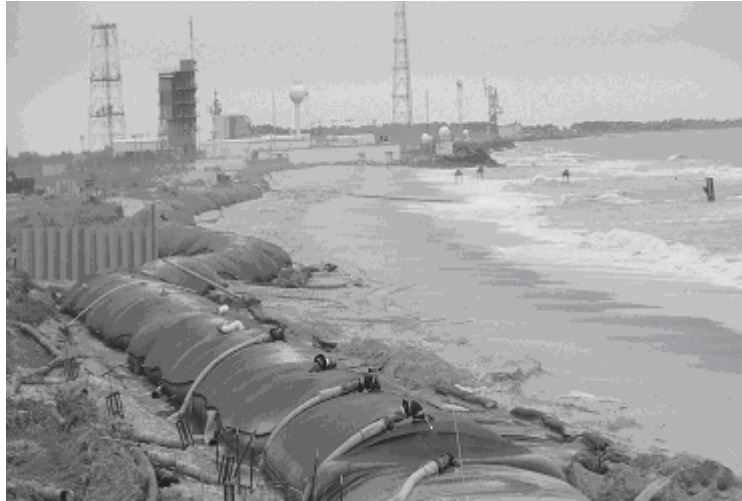
Figure 12 – Geotextile tubes shaped around existing structures.

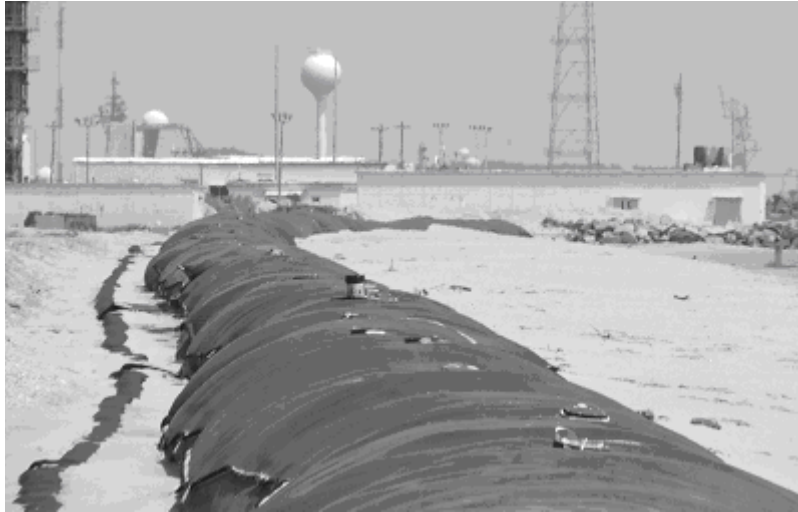
Figure 13 – Filled tubes with natural sand deposition on ocean side.

For the beach stabilization project, the geotextile tube breakwater has not only successfully discouraged shoreline erosion, but has encouraged sand deposition for the entire length of the project despite numerous tropical storms that have ravaged the shoreline. Evidence of miscellaneous debris washing up with the surf and coming to rest on or near the geotextile tubes has yielded little or no negative effect on the tubes themselves. Further stabilization has been secured as the client filled in the back side of the tubes with sand and planted dune grass to further control erosion. Neither the launch pad nor the landing strip has experienced any further degradation due to erosion. The client is monitoring the effects of the natural elements on the tubes closely, and has so far been encouraged that the geotextile tube fix may prove to be a longer term solution than initially anticipated.
